## Troubleshooting Contamination problems with an Electron Capture Detector

### Troubleshooting contamination problems

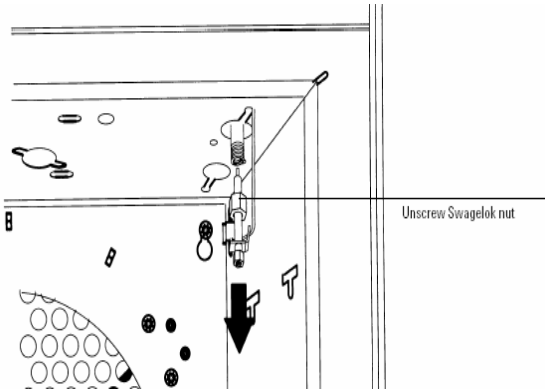
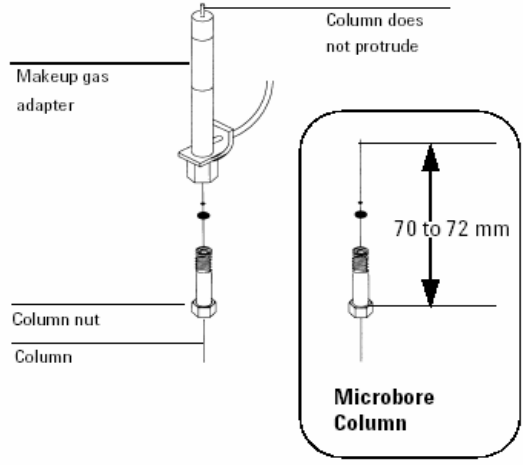
Remove the column from the detector and inspect the installation of the makeup gas adapter. It is quite common for the adapter to be installed too low. To check this, measure from the bottom of the 1/4-inch Swagelok nut to the bottom of the hex of the makeup gas adapter. The measurement should be 19 to 20 mm. If it exceeds 22 mm, the adapter is installed incorrectly. A ridge inside the cell can prevent the adapter from easily seating all the way. Wiggle the adapter while installing to allow it to go all the way in. Always check the nut to hex measurement to be sure. Please refer the figure.

2. Reconnect the makeup gas adapter using new 1/4-inch Vespel ferrule. Be sure it is fully seated— check the measurement. Retighten after the detector has been heated. Instead of the column blank the bottom of the makeup gas adapter with blanking nut (P/N 5181-8830) and Vespel/Graphite ferrule (P/N 5181-3308)
